TECHNICAL REPORT REMR-CO-3

CASE HISTORIES OF CORPS BREAKWATER
AND JETTY STRUCTURES

Report 7

NEW ENGLAND DIVISION

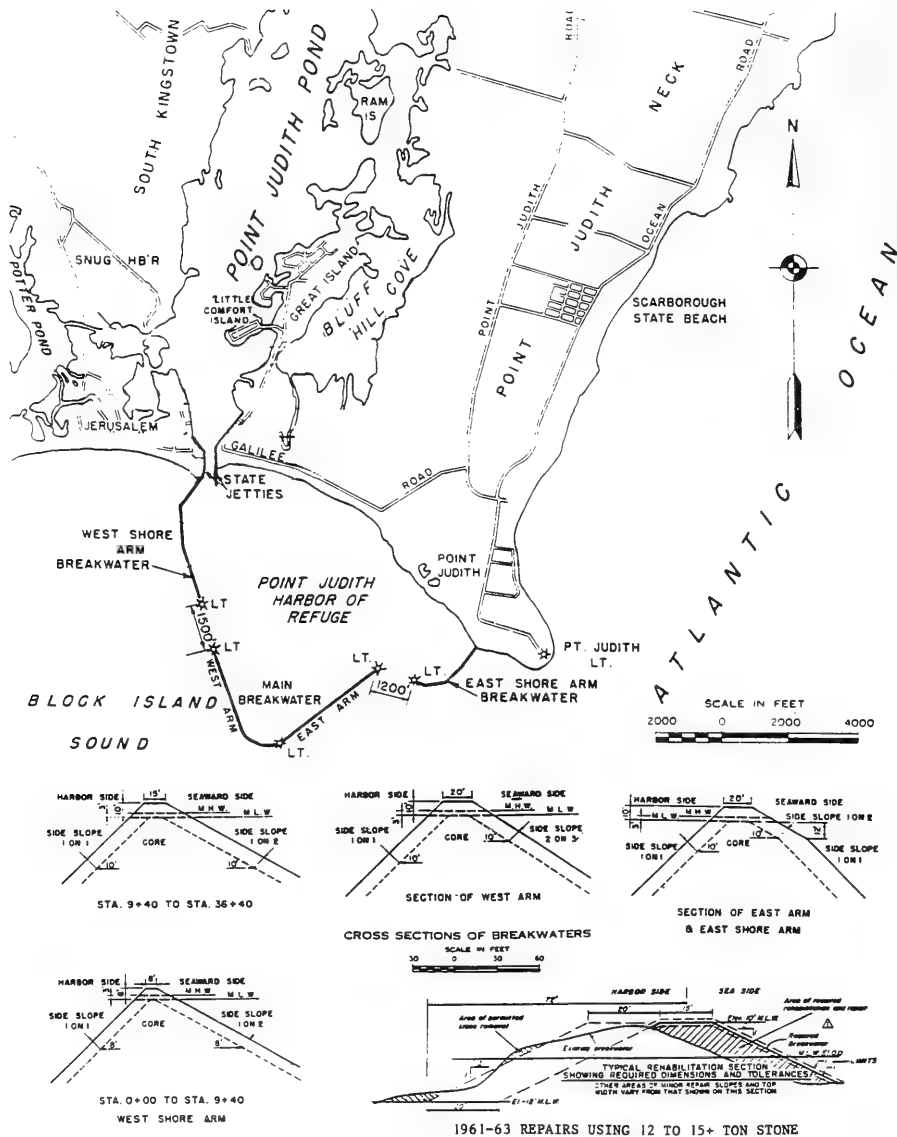
Figure 40. Plan view and typical sections of breakwaters at Point Judith Harbor of Refuge, R.I.

<u>Date(s)</u>	<u>Construction and Rehabilitation History</u>
1891-1914	Three rubble-mound breakwaters were constructed and maintained, providing a Harbor of Refuge at Point Judith (Figure 40). The 6,970-ft-long V-shaped main, 2,240-ft-long east shore arm, and 3,640-ft-long west shore arm breakwaters were built during 1891-99, 1903-09, and 1911-14, respectively. The main breakwater was constructed in water depths from 18 to 34 ft (relative to mlw), and the east and west shore arms were built in depths of up to 26 and 18 ft, respectively. The design cross section for the main and east shore arm breakwaters (Figure 40, inset) had a +10 ft mlw crown elevation, a 20-ft crown width, a 1V:1H harbor side slope, and a composite sea-side slope of 1V:2H and 1V:1H above and below -12 ft mlw, respectively. Subsequent to construction of the main breakwater (date unknown), the design sea-side slope on its west arm was changed to 1V:1.5H. Two design cross sections were used on the west shore arm breakwater (Figure 40, inset). The landward 940 ft had an 8-ft crown width and a +8 ft mlw crown elevation, and the remaining seaward section had a 15-ft crown width and a +10 ft mlw crown elevation. Slopes on both sections were 1V:1H and 1V:2H on the harbor and sea sides, respectively. Core stone (size unknown) was placed to mlw on all sections and facing stone (i.e. cover stone, size unknown) was placed to a thickness of 10 ft on all sections, except on the west shore arm's landward section where the thickness was 8 ft. A total of 1,421,500 tons of stone was placed at total construction costs of \$2,149,500. Starting in 1905, repairs were made on previously completed portions of the breakwaters by adding and resetting stone. Most of the repairs were located on the east arm of the main breakwater and the east shore arm breakwater. These areas were exposed to the largest waves generated by several winter storms which occurred during this period. Maintenance costs totaled approximately \$190,000 using an additional 36,400 tons of stone.

1927-1929	Repairs were made to the main and east shore arm breakwaters which had numerous deficiencies in cross section due to wave attack. The west shore arm breakwater was in good condition. Approximately 40,000 tons of stone were used for a total cost of \$203,400.
1935	The main breakwater was repaired using 6,760 tons of stone for a total cost of \$23,000.
1939-1941	Damaged sections of the main and east shore arm breakwaters, sustained during a 1938 hurricane, were repaired using new and reset stone. A total of 46,700 tons of new stone and 4,980 tons of salvaged stone were placed for a total cost of \$253,400.

Date(s)	Construction and Rehabilitation History
1950	<p>The breakwaters were repaired; and the landward end of the west shore arm breakwater and the state-owned east jetty, lying on either side of the Point Judith Pond entrance channel, were sand tightened. The sand-tightened sections, 600 and 700 ft long on the jetty and breakwater, respectively, were made by placing a 2-ft-thick layer of 3-in to 500-lb quarry-run stone followed by a 3-ft-thick layer of 1- to 4-ton cover stone on the seaward side slopes. The estimated stone quantity needed for sand tightening was 6,000 tons. The breakwater repairs were made at numerous sections located throughout the east arm of the main breakwater and from 7+50 to 21+25 of the east shore arm breakwater (landward end at 0+00). Approximately 115 lin ft at the seaward end of the original east shore arm was not repaired. Four sections totaling 120 lin ft were repaired on the west shore arm breakwater. The damaged sections were typically 3 to 5 ft below the design crown elevation of +10 ft mlw. The design geometry had 1V:1H harbor side and 1V:2H sea-side slopes, and crown widths of 20, 20, and 15 ft on the east shore arm, main, and west shore arm breakwaters, respectively. The estimated stone quantity needed for repairs was 13,215 tons of 1- to 6-ton stone. Total cost of the improvements was \$135,200 using a total of 19,090 tons of stone.</p>

1961- 1963	<p>The breakwaters were rehabilitated (Figure 40, inset) using 119,000 tons of stone for a total cost of \$1,771,900. The east shore arm was repaired from 9+50 to the reconstructed seaward end at 20+00. The main breakwater was repaired from the seaward end of the west arm at 0+00 to 4+00, at 10+50, and from 31+00 to the seaward end of the east arm at 69+25. Eleven areas, the largest covering 60 lin ft, of the west shore arm were repaired between 12+80 and the seaward end at 36+10. Stone placed on the structures weighed 12 to 15 tons, except for several sections along the east arm where a 15-ton minimum was specified. The repair areas required a +10 ft mlw crown elevation. The east and east shore arm repairs required a 15-ft crown width and 1V:2H side slopes. The west and west shore arm repairs specified 20- and 15-ft crown widths, respectively, with slopes of 1V:1.5H and 1V:1H on their sea and harbor sides, respectively. Prior to rehabilitation, crown elevations within the repair areas were typically from +4 to +9 ft mlw on the east and west arms, 0 to +8 ft mlw on the east shore arm, and +7 to +10 on the west shore arm. Crown elevations outside the repair areas were typically within 2 ft of the +8 and +10 ft mlw design elevations. Overall, the east arm and outer half of the east shore arm were the most deteriorated sections of the breakwaters prior to rehabilitation.</p>

1964- 1978	<p>Visual inspections show a gradual deterioration of the main and east shore arm breakwaters. The west shore arm had some displaced stone but was otherwise considered to be in good condition. By 1978, the</p>

Date(s)	Construction and Rehabilitation History
1964- 1978 (cont.)	main and east shore arm breakwaters were in poor to very poor condition with numerous deficiencies in cross section, and there were significant amounts of displaced stone on the harbor side of the structures at several locations.
1983- 1984	The east shore arm breakwater was repaired, and the main breakwater repairs were started but were not completed due to contractual difficulties. The east shore arm repairs were made using 12- to 15-ton stone and resetting existing stone. The majority of the repairs were located on the seaward half of the breakwater from 10+50 to 20+30. The breakwater was rebuilt to a +10 ft mlw crown elevation, a 20-ft crown width, and slopes of 1V:2H and 1V:1H on the sea side and harbor side, respectively. The cost of repairs was \$702,500 for 20,275 tons of new stone and \$81,870 for resetting existing stone. The incomplete main breakwater repairs were identical to the east shore arm repairs in stone weight and cross section geometry, except for the side slopes which were 1V:1.5H from 0+00 to 20+34 and 1V:2H from 20+34 to 67+25. The contract, awarded in the amount of \$2,275,000, called for placing 57,600 tons of stone and resetting existing stone.

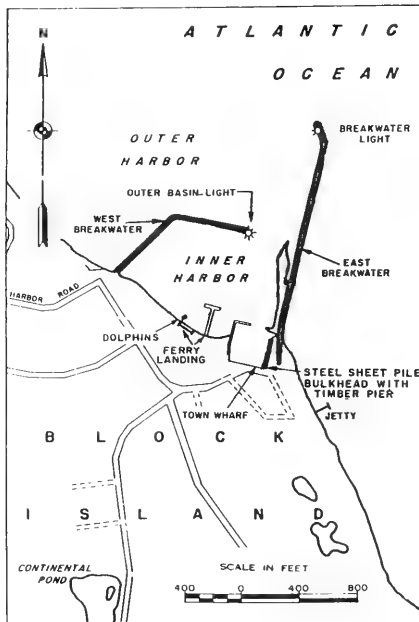
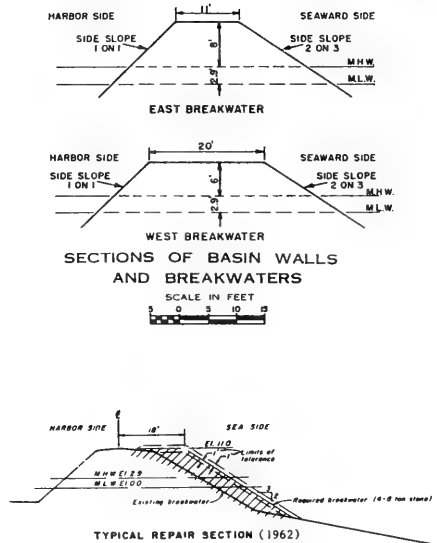
Figure 41. Plan view and typical sections of breakwaters at Block Island Harbor of Refuge, R.I.

Date(s)	Construction and Rehabilitation History
1870- 1894	The east and west rubble-mound breakwaters were constructed to lengths of 1,950 and 1,100 ft, respectively (Figure 41, plan view). The east breakwater was built to +10.9 ft mlw with an 11-ft top width, and the west breakwater was built to +8.9 ft mlw with a 20-ft crest width. The sea and harbor side slopes on both structures were 1V:1.5H and 1V:1H, respectively. A total of 107,400 tons of stone was used in constructing the east breakwater, and at least 18,400 tons of stone were used on the west breakwater. In 1890 minor repairs were made to the east breakwater using 420 tons of stone.
1903- 1906	The east breakwater was repaired using a total of 19,970 tons of stone at a total cost of \$42,900.
1914- 1916	Repairs were made at the landward and seaward ends of the east breakwater using a total of 5,930 tons of stone.
1939	Repairs were made to the east breakwater using 3,360 tons of stone for a total cost of \$21,000.

1950	The west breakwater was repaired to its design cross section using 0.25- to 6-ton cover stone and "run of quarry" core stone. Typical crest elevations prior to repairs were from 1.5 to 3.0 ft below the design elevation of +8.9 ft mlw. Total cost of the repair was \$127,100 using 12,900 tons of stone.
1955	An 800-ft section of east breakwater was repaired and sand tightened by placing 0.75-in. to 200-lb core stone and 1- to 6-ton cover stone. The stone was placed on the breakwater's seaward side slope beginning at a point opposite the northeast corner of the inner basin and terminating about 750 ft from the structure's seaward end. The cross section had a crown elevation of +11 ft mlw, the crown width extended seaward 25 ft from the existing breakwater center line, and the side slope was 1V:1.5H. A total of 12,000 tons of stone was placed for a total cost of \$125,000.
1962- 1963	The seaward 842 ft of the east breakwater were repaired using 4- to 8-ton stone. Prior to repair, center-line elevations were from +9 to -2 ft mlw on the seawardmost 200 ft, +9 to +12 ft mlw along the remaining 642 ft of repairs, and +10 to +12 ft mlw landward of the repairs. The repair crown section consisted of a +11 ft mlw crown elevation, an 18-ft crown width, and slopes of 1V:1H and 1V:1.5H on the harbor and sea sides, respectively. Most of the stone was placed on the sea-side slope. A total of 11,700 tons of stone was used for a total cost of \$138,000.

Date(s)	Construction and Rehabilitation History
1977	Inspections up to this time indicated the west breakwater was in good condition and the east breakwater was in fair to good condition. Repair work was needed on the seaward 150 ft of the east breakwater where settlement and loss of sea-side slope stone had occurred since the 1962-63 repairs. Maintenance was subsequently performed.
1984-1987	Yearly visual inspections indicated the breakwaters were considered to be in good condition.

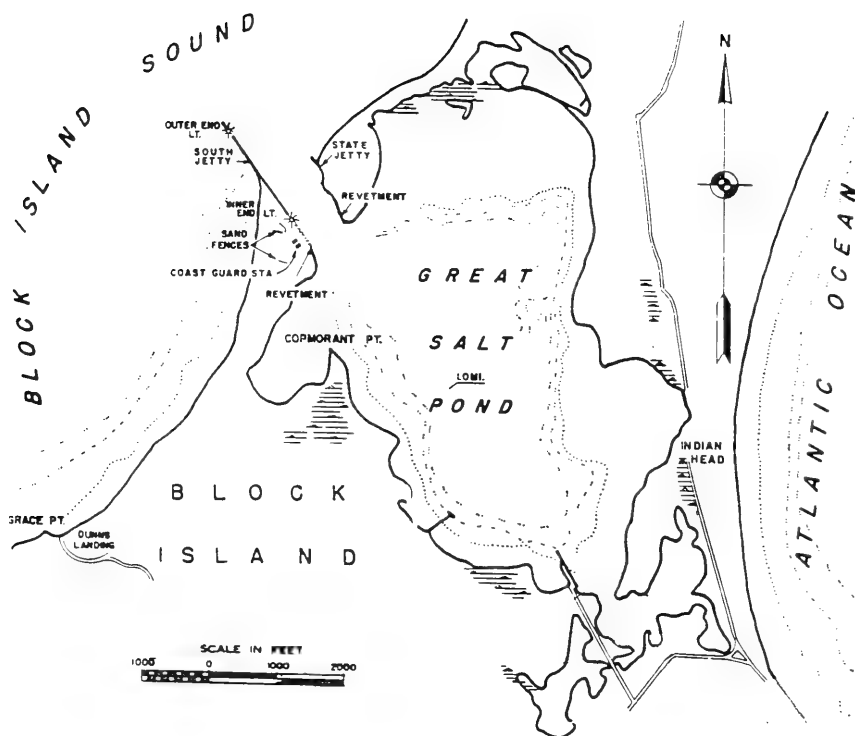
Figure 42. Plan view and cross section of south jetty at Great Salt Pond, Block Island, R.I.

<u>Date(s)</u>	<u>Construction and Rehabilitation History</u>
1896- 1905	A 1,690-ft-long rubble-mound jetty was constructed on the south side of the inlet to Great Salt Pond (Figure 42). The design cross section consisted of a +8 ft mlw crown elevation, a 15-ft crown width, and slopes of 1V:2H and 1V:1H on the sea and channel sides, respectively. The structure's seaward end extended approximately 400 ft beyond the -18 ft mlw contour. A total of 66,860 tons of stone were placed at a cost of \$84,900.
1935	Minor repairs were made to the jetty using 1,600 tons of stone for a cost of \$5,700.
1965- 1977	Visual inspections indicated the jetty was in poor to fair condition and in need of repairs. The outer half of the jetty had many void spaces and areas of displaced stone. Subsequent repair work was performed.
1982	Annual visual inspection indicated the jetty to be in good condition.
1986	The present condition of the jetty is not known.

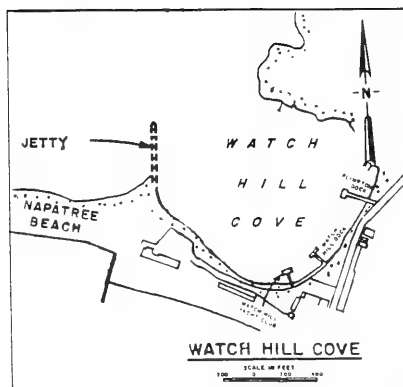
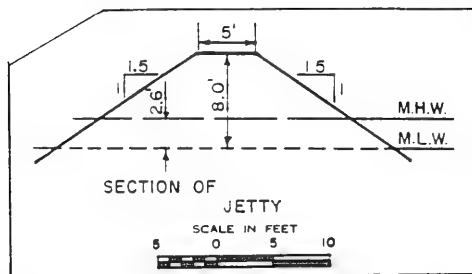
Figure 43. Jetty at Watch Hill Cove, R.I.

- 1948 A 400-ft-long rubble-mound jetty was constructed on the west side of Watch Hill Cove (Figure 43). The jetty was built to an elevation of +8.0 ft mlw, a top width of 5 ft, and 1V:1.5H side slopes. The core consisted of run of quarry stone and cover stone weighed between 600 lb and 2 tons. The cost for placing 456 tons of stone was \$3,990.
- 1974 The jetty was in good condition, with only minor displacement of stone noted along its outer 150 ft.
- 1982-1986 Annual visual inspections indicated the jetty was in good condition.

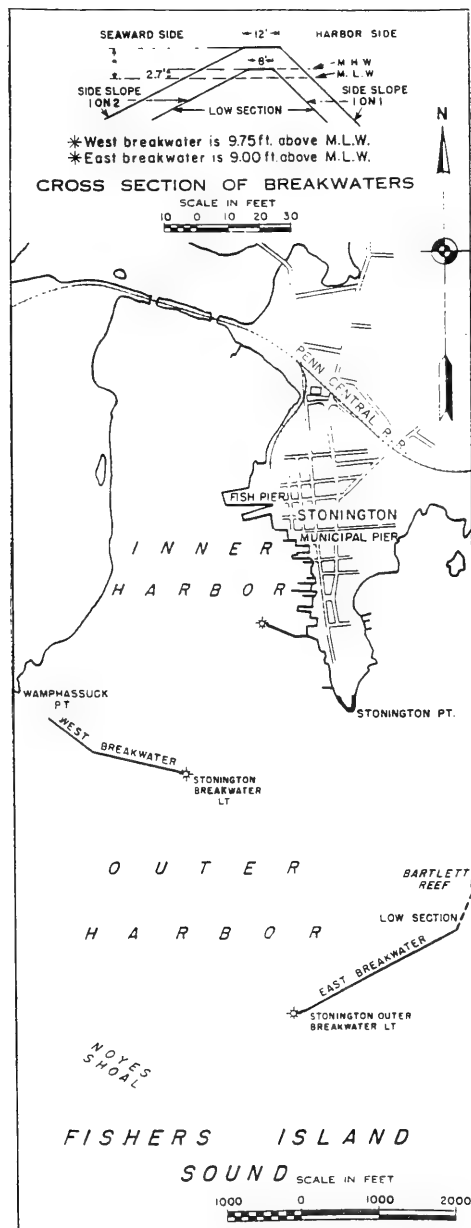
Figure 44. Plan view and cross sections of breakwaters at Stonington Harbor, Conn.

<u>Date(s)</u>	<u>Construction and Rehabilitation History</u>
1875- 1894	The west and east breakwaters, 2,025 and 2,900 ft long, respectively, were constructed using total stone quantities of 94,200, and 118,500 tons, respectively (Figure 44). The structures crown widths were 12 ft, and side slopes were 1V:2H and 1V:1H on the sea and harbor sides, respectively. The east and west breakwater crown elevations were +9 and +9.75 ft mlw, respectively. The easternmost 500 ft of the east breakwater was built lower than the remaining breakwater, having a crown elevation of +2.7 ft mlw and an 8-ft crown width. Total construction costs were approximately \$210,000.
1958	The breakwaters were repaired using 0.5- to 4-ton stone. Approximately 4000 tons of stone were placed to bring low sections up to their original design geometries (Figure 44, insert). The total repair cost was \$38,000.
1962- 1977	Visual inspections indicated the breakwaters were in good condition.

1984	Yearly visual inspections indicated that the breakwater was in good condition.

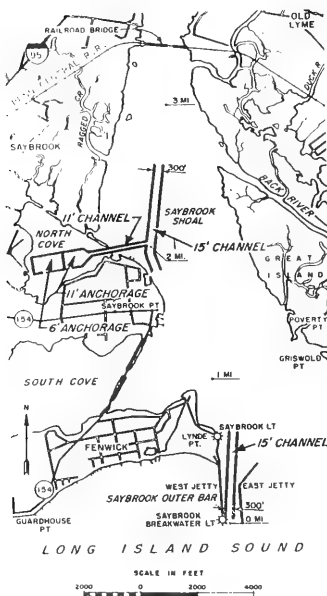
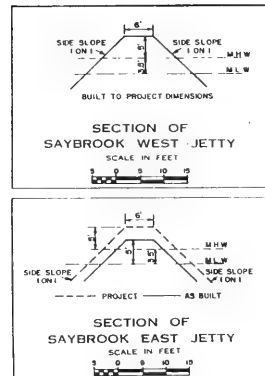
Figure 45. Plan view and design sections of jetties at the mouth of the Connecticut River, Saybrook, Conn.

Date(s)	Construction and Rehabilitation History
1873-1885	The east and west jetties were constructed at the mouth of the Connecticut River to lengths of 2,300 and 2,250 ft, respectively (Figure 45). The jetties had +5 ft mlw crown elevations, 6-ft crown widths, and 1V:1H side slopes.
1904-1905	The jetties were repaired using 7,650 tons of stone for a total cost of \$9,400. The jetties were restored to crown elevations of +5 to +6 ft mlw and crown widths of 6 ft.
1914-1916	The west jetty was repaired and raised to a crown elevation of +8.5 ft mlw. Approximately 16,000 tons of stone were used and 85 cu yd of concrete were placed at the landward end for a total cost of \$26,000.
1966-1978	The jetties were considered to be in good condition during visual inspections.
1984	Annual visual inspection of the jetties indicated they were in good condition. The jetties do not appear to have a repair history subsequent to 1916.

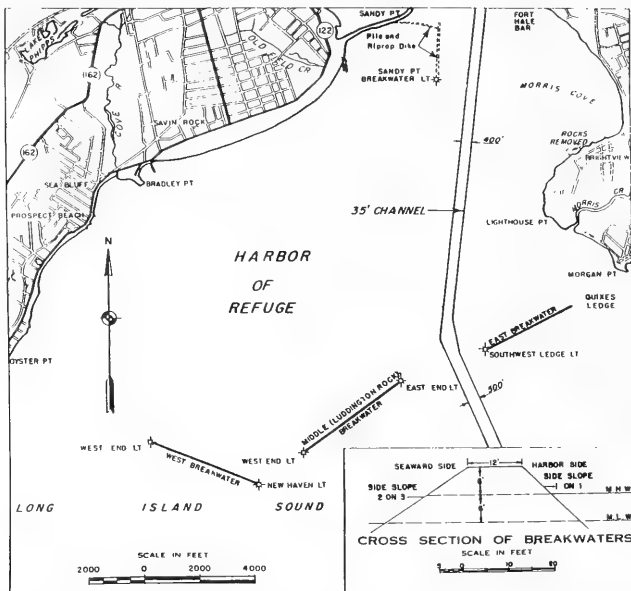
Figure 47. Breakwaters at New Haven Harbor of Refuge, Conn.

Date(s)	Construction and Rehabilitation History
1880-1915	Three rubble-mound breakwaters were constructed as part of the Harbor of Refuge at New Haven (Figure 47). The breakwaters were constructed to a crown elevation of +12 ft mlw, a 12-ft crown width, and slopes of 1V:1H and 1V:1.5H on the harbor and sea sides, respectively. The 3,450-ft long east breakwater was built during 1880-90 using 293,800 tons of stone and repaired in 1911 using 2,900 tons of stone. The 4,500-ft-long middle breakwater was built during 1891-96 using 339,000 tons of stone and repaired in 1911 and 1915 using 10,600 and 12,000 tons of stone, respectively. The 4,200-ft-long west breakwater was built during 1896-97 and 1907-11 using 478,100 tons of stone and repaired in 1915 using 14,300 tons of stone. The breakwater's construction costs during this period were approximately \$1,120,000.
1935	The breakwaters were repaired using 6,720 tons of stone for a total cost of \$18,500.

1960-1974	The breakwaters were considered to be in fair to good condition during several visual inspections taken over this period.
1984	Yearly visual inspection of breakwaters indicated they were in good condition.

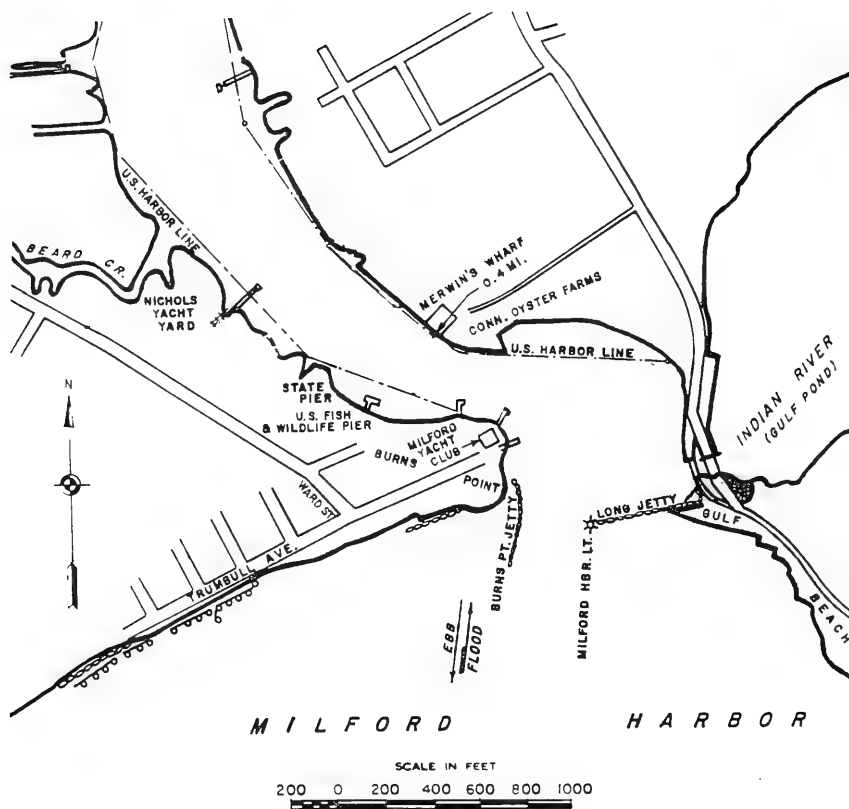
Figure 48. Plan view and cross sections of jetties at Milford Harbor, Conn.

<u>Date(s)</u>	<u>Construction and Rehabilitation History</u>
1875-1980	To provide protection to Milford Harbor and its entrance channel the Long (east) and Burns Point (west) jetties were constructed to lengths of 510 and 350 ft, respectively, using 4,100 and 900 tons of stone, respectively. The triangular cross section of the west jetty had a crown elevation between +7 and +8 ft mlw and 1V:1H side slopes. The east jetty cross section had a +10.5 ft mlw crown elevation, a 6-ft crown width, and slopes of 1V:1H and 1V:1.5H on the harbor and sea sides, respectively.
1948	The jetties were repaired using 1,153 tons of 0.5- to 2-ton stone. The east jetty was repaired to the original cross section, and the west jetty was built up to +7 ft mlw with a 2-ft crown width and 1V:1H side slopes. The repaired lengths of the east and west jetties were 500 and 350 ft, respectively. The total repair cost was \$13,700.

1963	The west jetty was repaired using 0.5- to 2-ton stone placed to the 1948 repair cross section. The contract cost for placing an estimated 1,450 tons of stone was \$19,400.
1965	The State of Connecticut rebuilt the east jetty and, near its outer end, constructed a 166-ft-long rubble-mound groin. The groin extended seaward in a nearly perpendicular direction from the jetty axis.
1968-1978	Inspections indicated the jetties were in good condition with some minor repairs needed on both.
1984	Annual visual inspections indicated the jetties were in good condition.

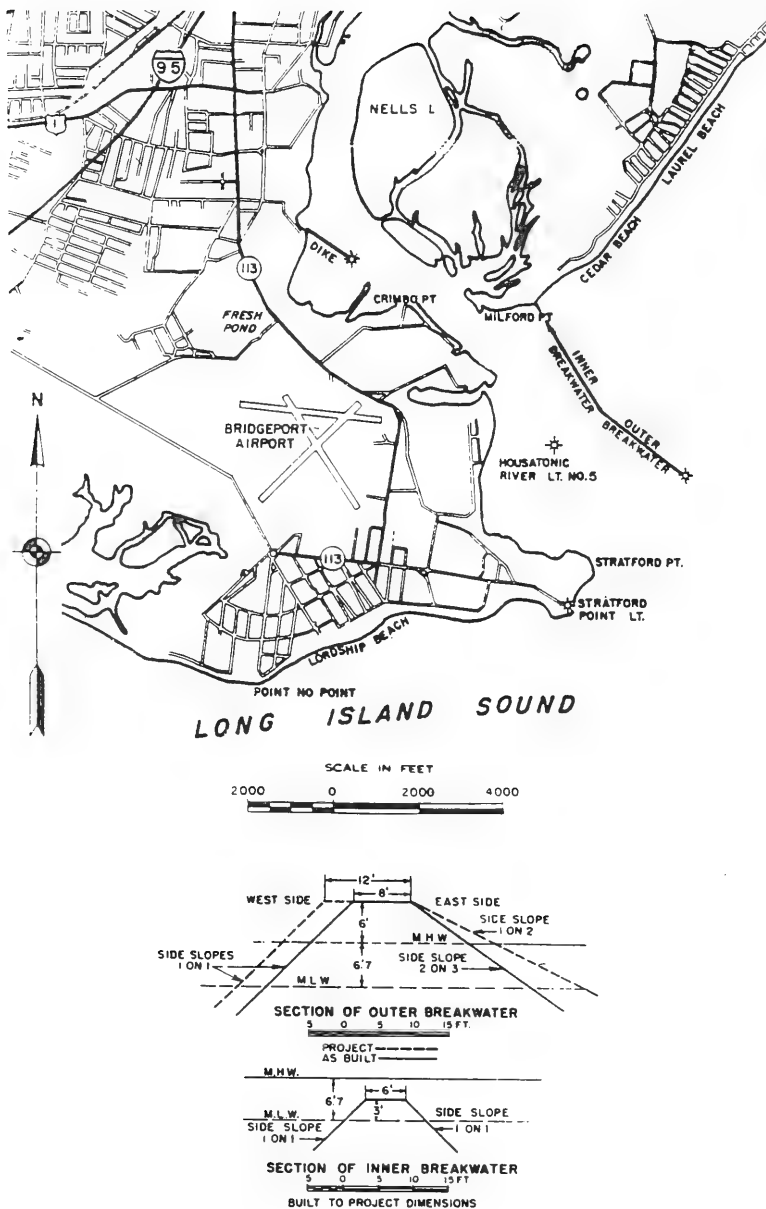
Figure 49. Plan view and cross sections of breakwater at the mouth of the Housatonic River, Conn.

<u>Date(s)</u>	<u>Construction and Rehabilitation History</u>
1889- 1895	The inner and outer arms of the Housatonic breakwater (Figure 49), 3,250 and 2,570 ft long respectively, were constructed using 12,500 and 44,560 tons of stone, respectively. The inner arm was built to approximately mid-tide level with a crown elevation of +3 ft mlw, a 6-ft crown width, and 1V:1H side slopes. The outer arm was constructed to a crown elevation of +12.7 ft mlw, and 8-ft crown width, and slopes of 1V:1H and 1V:1.5H on the channel and sea sides, respectively. The construction costs totaled approximately \$75,000.
1905- 1906	Repairs were made to both arms of the breakwater using a total of 3,990 tons of stone.
1911- 1916	During this period, the outer breakwater arm was extensively repaired using a total of 16,200 tons of stone. The crest width was increased to 12 ft, and side slopes of 1V:2H were placed on the sea side. In 1914, the inner arm was repaired using 1,000 tons of stone. Total repair costs were \$26,200.

1940- 1941	The outer arm was repaired using 1,350 tons of stone for a cost of \$6,700.
1960- 1977	Visual inspections showed the outer arm was in good condition, and only minor repairs were needed at the seaward end. The inner arm was in poor condition and needed repairs throughout its length.
1986	The present condition of the breakwater is not known.

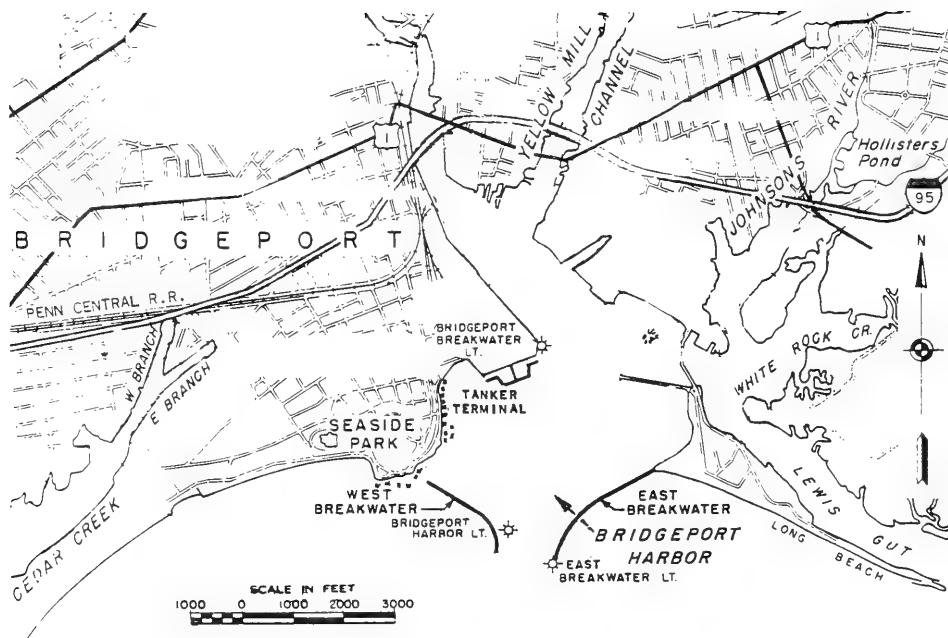
Figure 50. Breakwaters at Bridgeport Harbor, Conn.

<u>Date(s)</u>	<u>Construction and Rehabilitation History</u>
1871- 1973	The Bridgeport Harbor east breakwater was built to a length of 1,380 ft (Figure 50).
1900	The east breakwater was extended 380 ft using 5,080 tons of stone for a total cost of \$10,200.
1907- 1908	The east breakwater was extended to a total length of 3,823 ft using 43,560 tons of stone. The completed breakwater cross section consisted of a +9.5 ft mlw crown elevation, an 8-ft crown width, and slopes of 1V:1H and 1V:1.5H on the harbor and sea sides, respectively. Total cost of placing 43,560 tons of stone in the extension was \$51,000.
1908- 1909	The west breakwater was constructed to a length of 2,110 ft using 39,290 tons of stone for a total cost of \$46,000. The design section was identical to that of the east breakwater, except for the crown width which was 6 ft.
1935	The breakwaters were repaired for a total cost of \$12,500. Stone quantities placed on the east and west breakwaters were 3,300 and 1,170 tons, respectively.

1941	The east breakwater was repaired using 2,650 tons of stone for a total cost of \$13,000.
1960- 1978	Several visual inspections were made, and the breakwaters were generally in good condition. By 1978 the inspectors recommended the structures be considered for future maintenance.
1986	Present conditions of the breakwaters are not known.

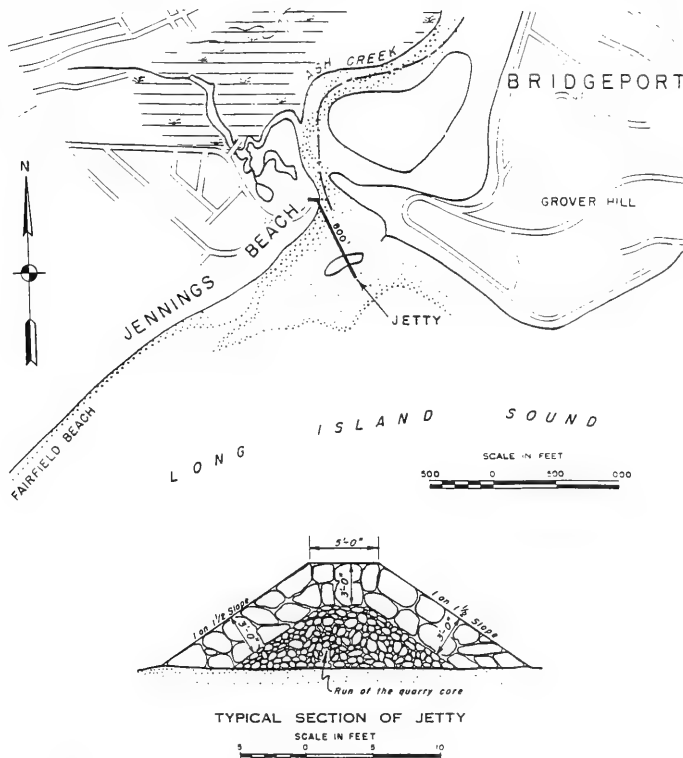
Figure 51. Plan view and cross section of jetty at Jennings Beach and Ash Creek, Conn.

Date(s)	Construction and Rehabilitation History
1951	An 800-ft-long sand-tight jetty was constructed on the west side (Jennings Beach) of the mouth of Ash Creek (Figure 50). The jetty cross section consisted of a +9 ft mlw crown elevation, a 5-ft crown width, and side slopes of 1V:1.5H. The jetty had a run of quarry core and a 3-ft-thick double layer of cover stone (size not known). The jetty was built by local interests who were reimbursed one-third the first cost of construction by the Federal government.
1986	The jetty has no known repair history, and its present condition is not known.

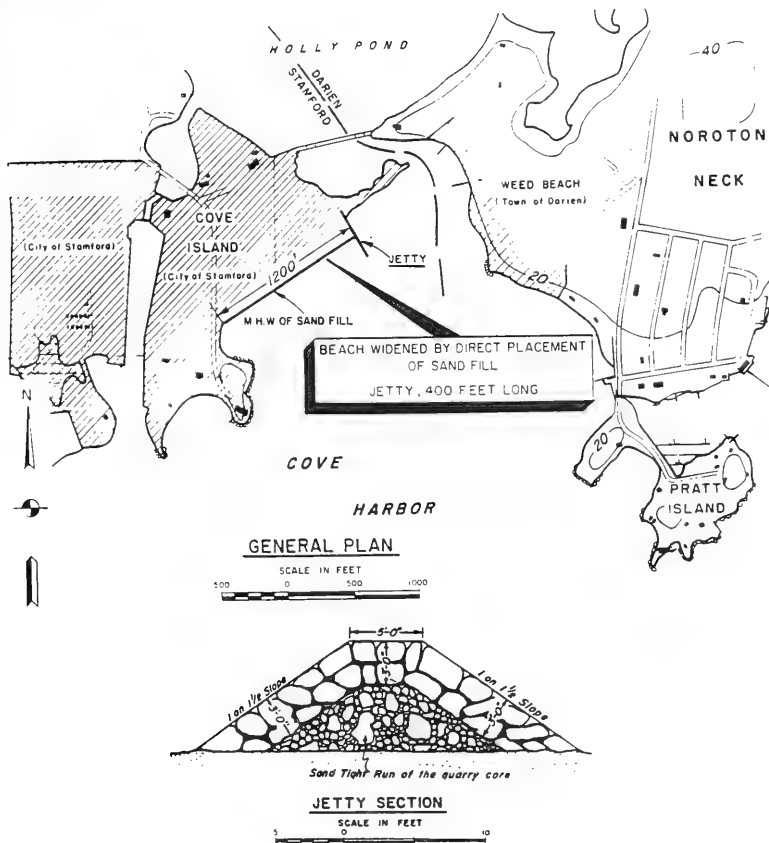
Figure 54. Cove Harbor Jetty, Cove Island, Conn.

Date(s)	Construction and Rehabilitation History
1958	A 400-ft-long jetty was constructed on the east side of Cove Island (Figure 54). The jetty consisted of a +10 ft crown elevation, a 5-ft crown width, 1V:1.5H side slopes, a sand-tight run of quarry core, and a 3-ft-thick double layer of cover stone. The State of Connecticut, which constructed the jetty, was reimbursed by the Federal government for one-third of the project cost.
1986	The jetty has no known repair history, and its present condition is unknown.

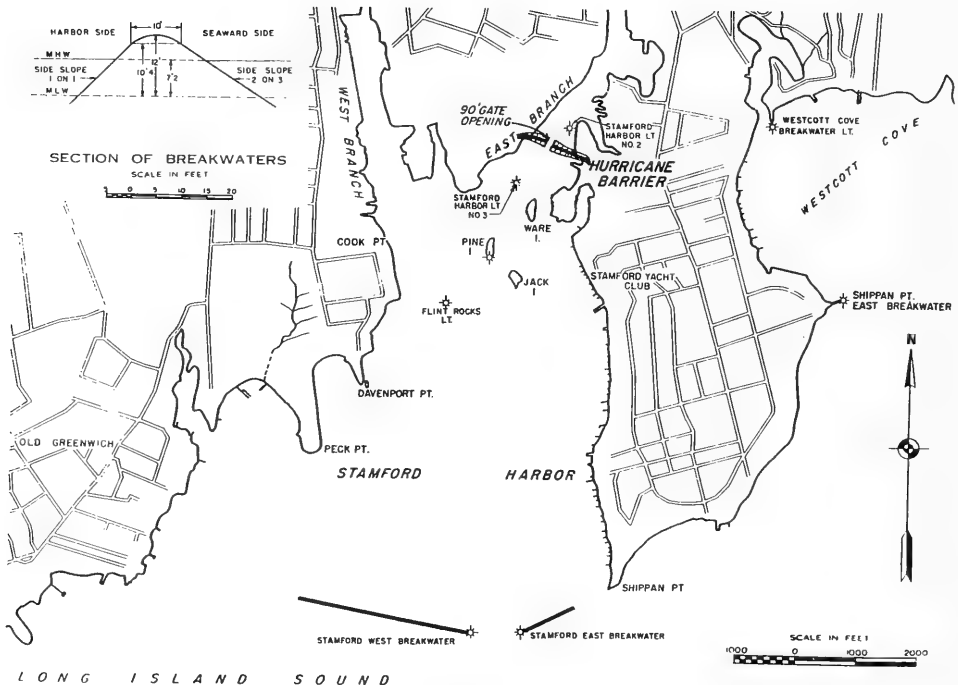
Figure 55. Plan view of breakwaters at Stamford Harbor, Conn.

<u>Date(s)</u>	<u>Construction and Rehabilitation History</u>
1940-1941	The east and west breakwaters (Figure 55) were constructed to lengths of 1,200 and 2,900 ft, respectively, using 40,100 and 118,100 tons of stone, respectively. The cross section had a maximum crown elevation of +12 ft mlw, a 10-ft crown width at +10.4 ft mlw, and slopes of 1V:1H and 1V:1.5H on the harbor and sea sides, respectively. The total construction cost was \$398,900.
1960-1977	Visual inspections indicate the breakwaters were in fair to good condition.
1986	Present conditions of the breakwaters are not known.
